Beach Erosion and Sediment Processes Study, North East Marina, Erie County, Pennsylvania

Andrew Morang and Jeffrey Melton

June 2001

Final report

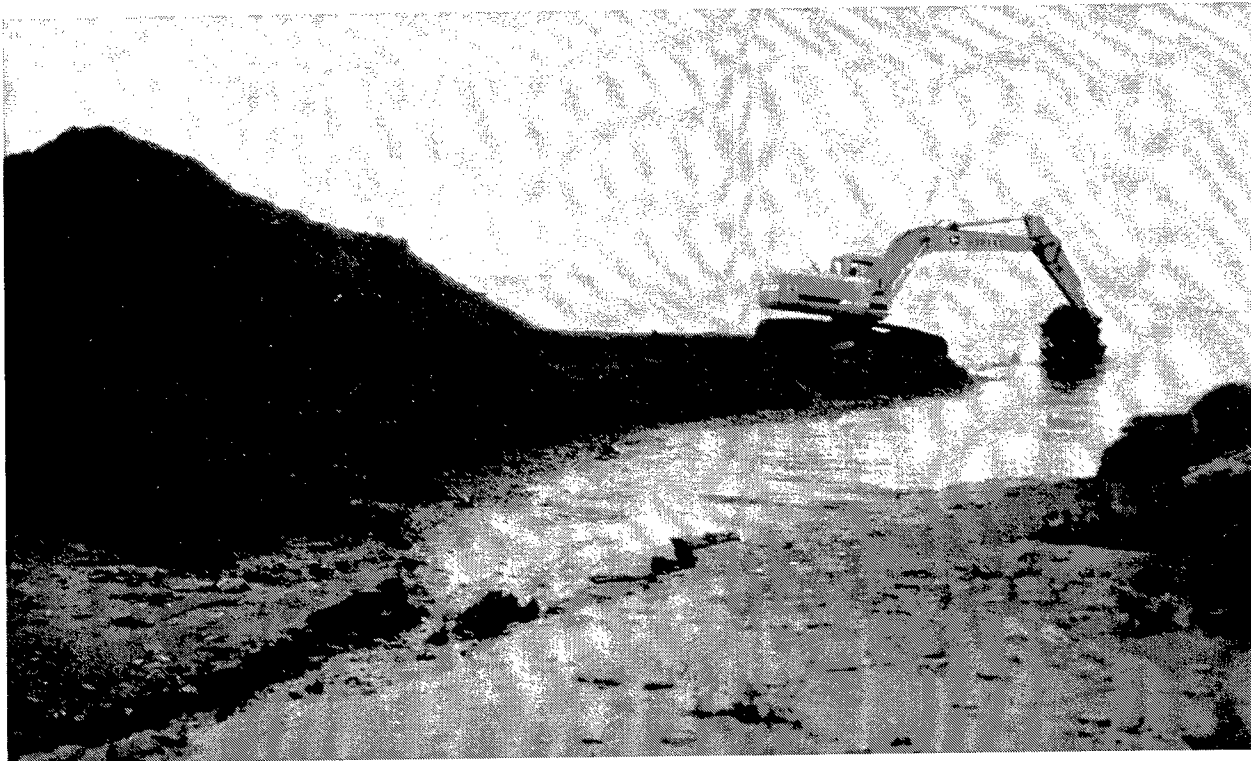
and gravel from the west side fillet into a 5-m-high pile. To obtain as much material as possible from the fillet, the backhoe operator builds a temporary road out into the lake (Figures 25 and 26). Dump trucks are loaded with sand and gravel on the west side, cross the marina, back up along the beach, and deposit their loads. The initial loads are used to build a road at the base of the bluff so that the trucks can proceed east away from the sheltering effects of the marina walls, up to a distance of about 500 m from the east wall (Figure 27). Then sand is spread on the beach and into the water, pushed about by bulldozer. Depending on waves, the road is sometimes partly washed away at night and has to be rebuilt in the morning. During the early 1990s, when lake levels were higher, the road had to be built into the lake to go around the barrels that protrude from one lakefront property.

Figure 26. Backhoe removing sand and gravel from updrift fillet, 17 November 1998. A temporary road allows backhoe to proceed out into lake over 30 m

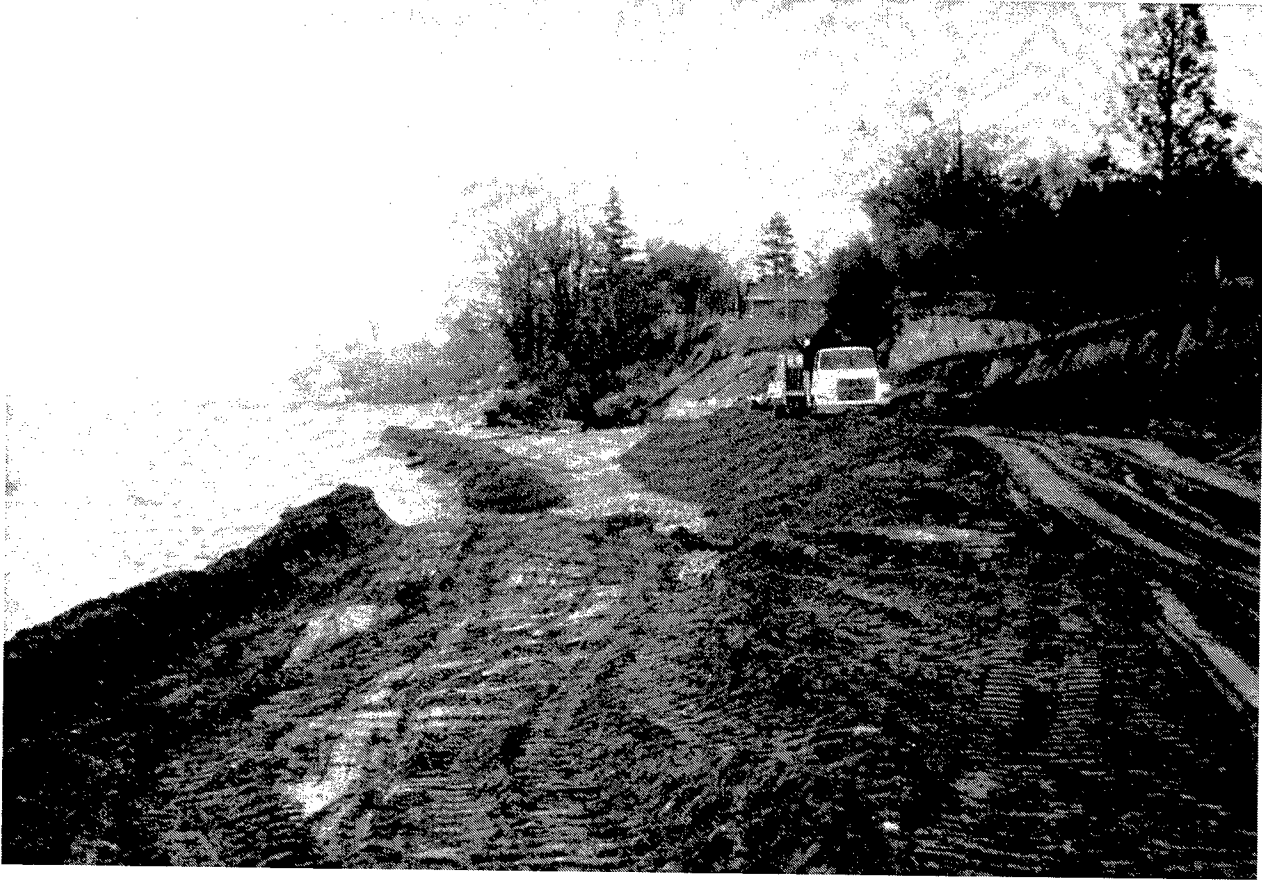
Figure 27. Temporary road along base of bluffs east of marina, 17 November 1998. Sediment is spread across beach and into water by a bulldozer

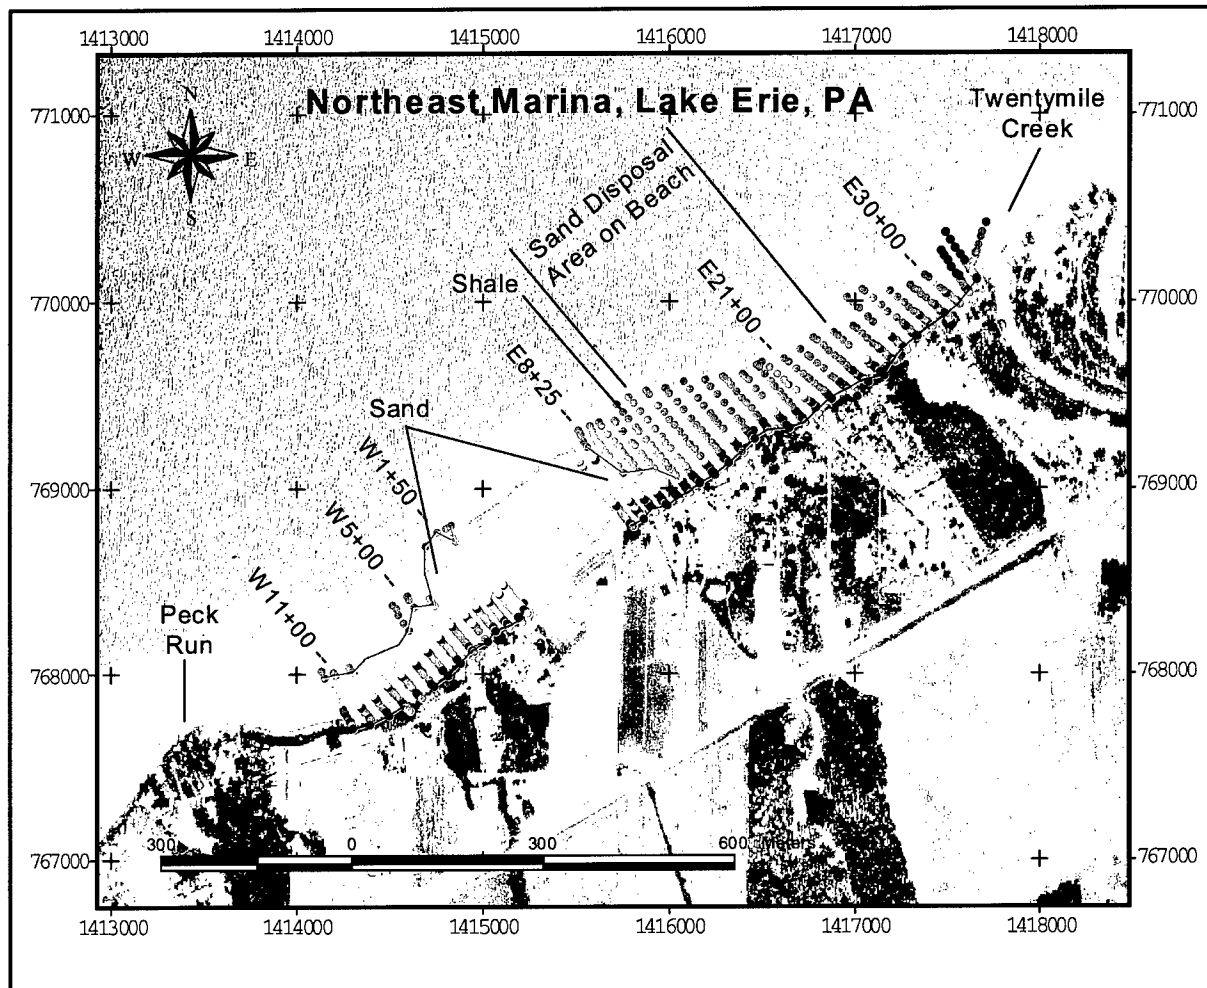
Figure 30. September 1999 profiles. State plane coordinate system, Pennsylvania North Zone, NAD 83, units in feet. Photograph is USGS digital ortho quarter quadrangle, converted from UTM coordinates to PA state plane (To convert feet to meters, multiply by 0.3048)

- c.* The volume of sand east of the marina has approximately doubled since 1992. This sand is found in a fillet that extends about 120 m east of the east wall (Figure 30). Part of this volume is in the upper beach, remnants of the temporary roadway placed by the PFBC.

- h.* Based on the analysis of profile volumes, line E1050 is the easternmost limit where the influence of the marina can be detected with respect to sediment accumulation (or loss) on the beach (Figure 30). This profile is about 120 m (400 ft) east of the east wall. East of E1050, the 1999 profile volume is essentially unchanged compared to 1991 and 1992. The quantity of sand on the beach in this area, east of E1050, is minimal, only about 4 yd³/ft.

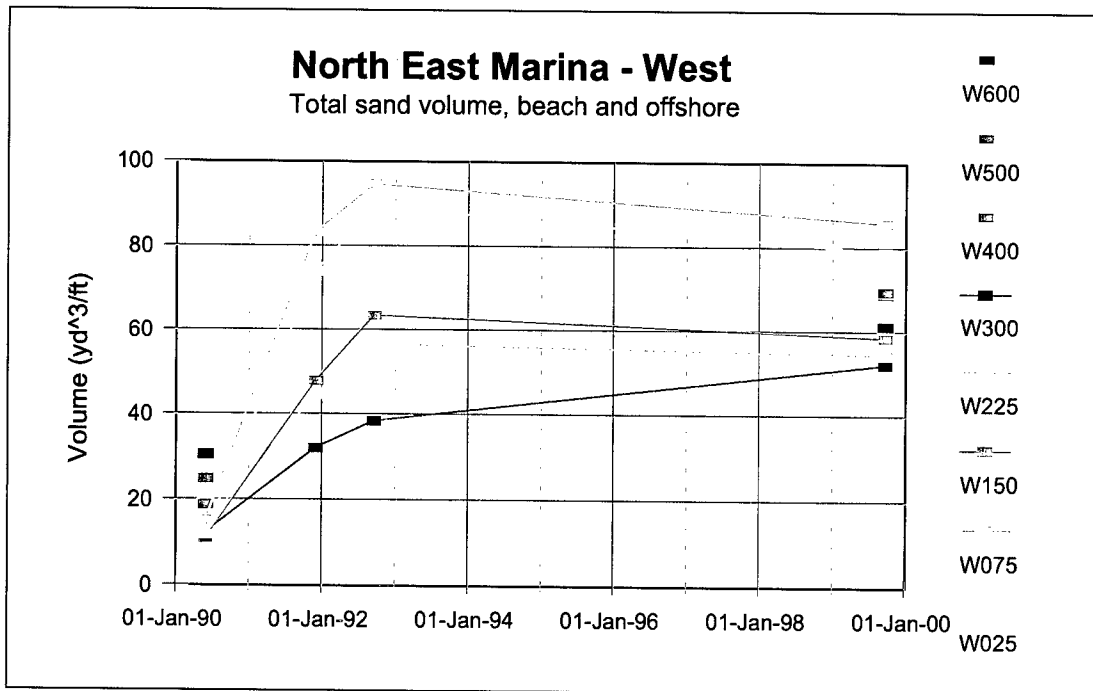
The results are easier to visualize as graphs. Figure 36 shows the volume changes over time for the west profiles. At all locations, volume increased rapidly between 5-30-90 and 9-16-92, during the period of marina construction, especially at lines W025 and W075. These data confirm the visual observations that a large fillet grew on the west side of the marina wall. The recent survey, 9-24-99, shows that the volumes of most of the west lines have stabilized or even slightly decreased. The period of stable overall volume coincides with the years that the PFBC has been bypassing sand from the west to the east side of the project. Only at line W300 did the volume increase from 1992 to 1999, and this is accounted for by the accumulation of sand on the upper part of the beach (see Appendix C). This is private property, west of the area where the PFBC mines the beach during its spring and fall bypassing operations.

Figure 36. Profile volume for lines W025 to W600 west of marina west wall. At W400, W500, and W600, data are only available for 1990 and 1999 and points have not been connected in this plot

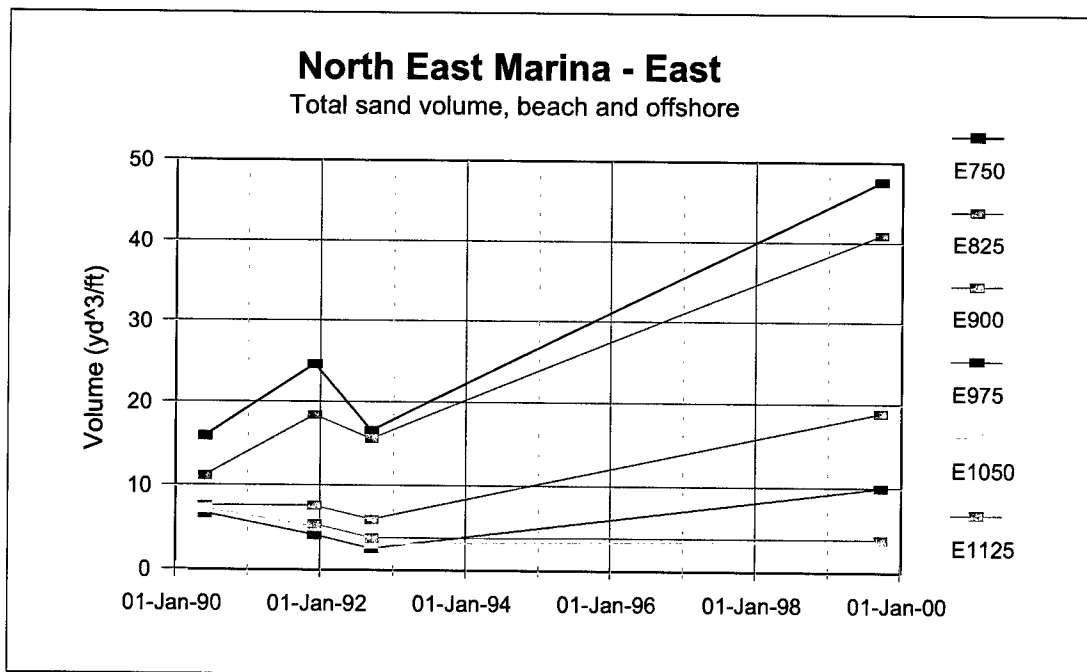
East of the marina, beach volume decreases towards the east (Figure 37). At the two lines closest to the east wall, E750 and E825, volume has more than doubled since 1992. Overall elevation has increased 0.3-0.6 m across the entire

beach, from the bluff toe to about 130 m offshore. Directly in front of the bluff, part of the 1998 fill remains as a raised terrace. Thanks to a mild winter storm season and dropping lake levels, the trucked fill was not completely removed as it had in previous winters. Profiles E900 and E975 also show volume increase, but to a lesser extent than the two lines closer to the marina. Profiles E1050 and E1125 were stable volume over time. These indicate that E1050 is about the easternmost limit where the influence of the marina can be detected with respect to sediment accumulation (or loss) on the beach.

Figure 37. Profile volumes east of marina. Most profiles show an increase in volume since 1992, but E1050 and E1125 are beyond influence of the structure

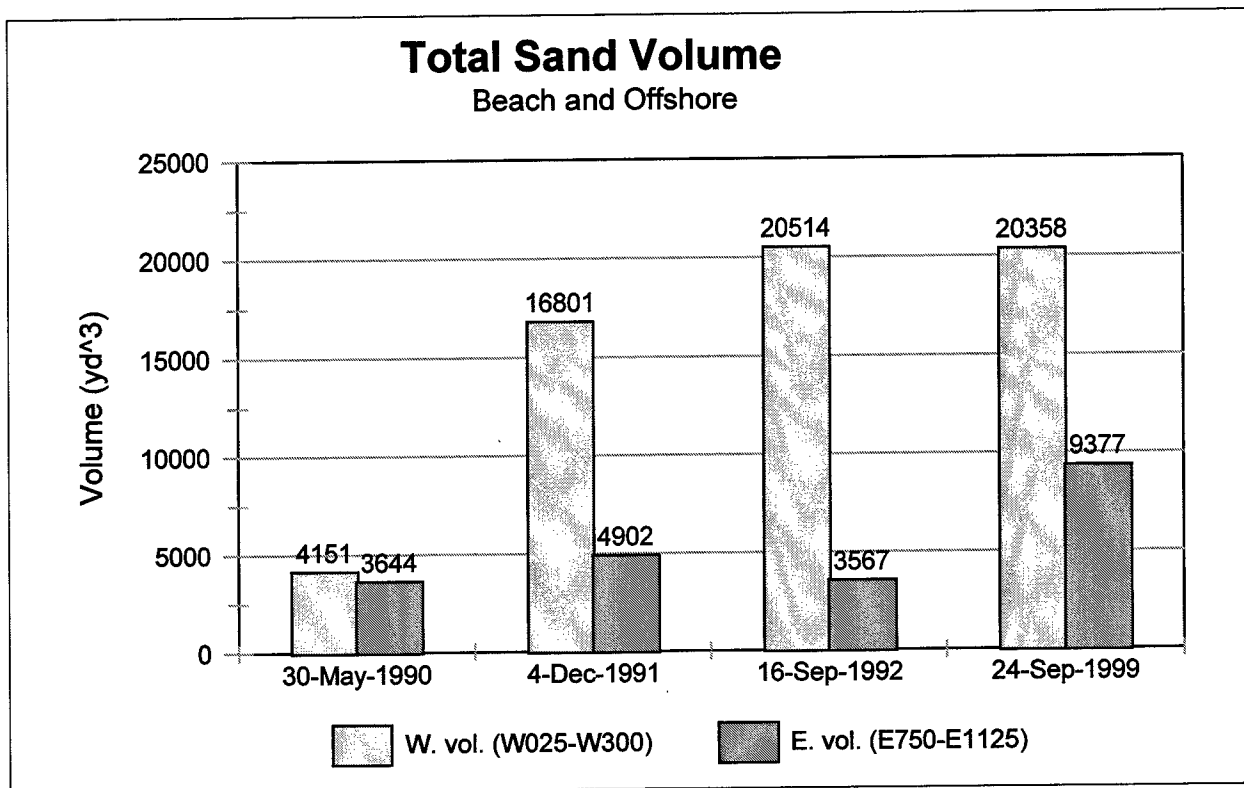
Figure 38 summarizes total volume change over time for the east and the west beaches. The west beach volume between W025 and W300 is almost identical to the 1992 volume, while the east beach has almost doubled. These data indicate that the PFBC has been bypassing a sufficient amount of sand to prevent a volumetric increase on the west side of the marina.

Figure 38. Total volume for west and east beaches. West of marina, volume has been stable since 1992, while to the east, total beach volume has almost doubled

Period 2: Spring 1994 to the present. Pennsylvania Fish & Boat Commission has effectively mitigated the disruption of eastward-directed littoral transport because the volume of sand bypassed during the biannual trucking operations has been approximately the same as the amount of sand brought into the fillet region by littoral processes. In September 1999, the total volume between profiles W025 and W300 remained unchanged at about 20,000 yd³, therefore indicating that the mechanical bypassing has been equal to the input supply (Figure 38).

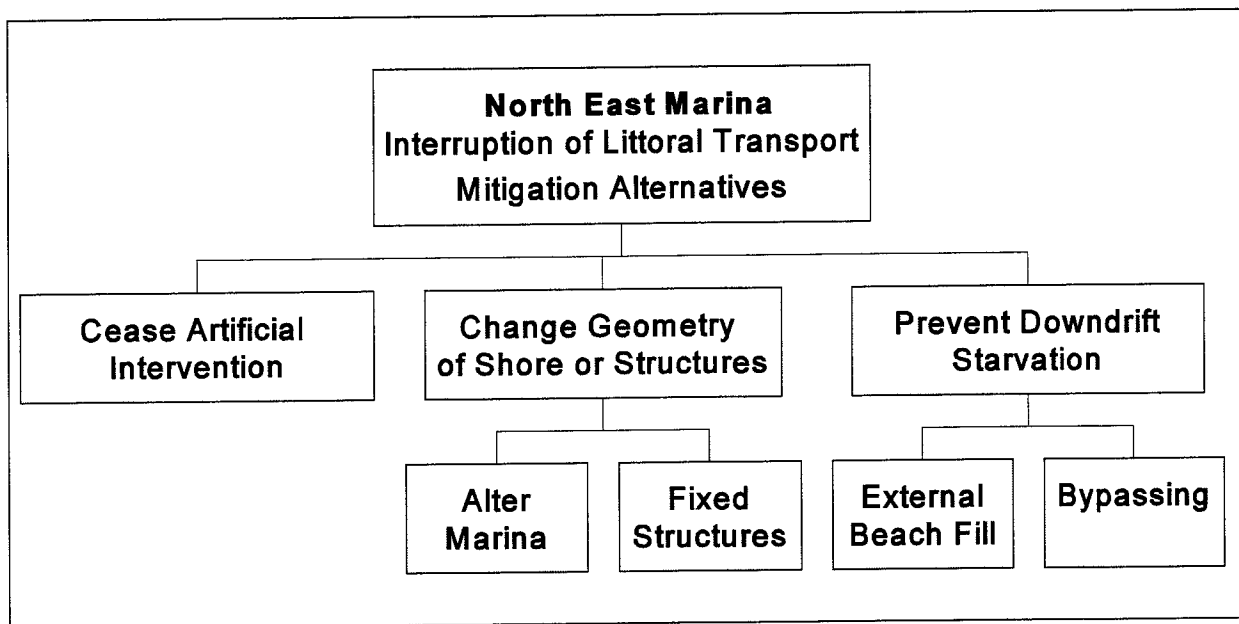
Figure 39. Flow chart of mitigation alternatives

Solution		Recommendation
Cease Artificial Intervention		Permanent loss of material offshore, unknown time frame, failure to nourish east beach
Change Geometry of Shore or Structures		
<i>Alter marina</i>		
·	Complete removal of North East Marina breakwater walls and riprap	Cost-prohibitive, need for harbor of refuge along this coast, debris disposal
·	Partial removal of marina walls	Reduced protection for boats, tombolo formation, high cost
<i>Fixed structures</i>		
·	Shore-perpendicular groins along beach east of marina.	Detrimental downdrift effects, cost-prohibitive, requires beach fill
·	Detached breakwaters along east beach.	Cost-prohibitive, requires beach fill
·	Headland or on-shore breakwaters to perch the shoreline	Cost-prohibitive, requires beach fill
·	Revetment/seawall along east beach.	Property protection only, no benefit to beach
·	Above structure options considering alternative construction material (i.e., precast concrete units, geotextile, etc.)	Cost-prohibitive, typically ineffective in Great Lakes

Prevent Downdrift Starvation		
<i>Beach fill from external sources</i>		
·	Dredge sand from submerged sites	No nearby offshore source
·	Mine the spit at the mouth of Twenty Mile Creek and back-pass the material to the east beach	Detrimental downdrift effects
·	Purchase and import sand by truck from an inland source	Cost-prohibitive, disruptive to community
·	Combine backhoe and truck sand bypassing with external sand supply	Not needed
·	Place coarser, more stable gravel or cobble on east beach	Reduced recreation
<i>Sand bypassing using west beach fillet</i>		
·	Continue sand bypassing using existing procedures	Optimum solution for North East Marina
·	Bypass using existing procedure (backhoe and trucks) but more frequently or on a flexible schedule.	Not needed
·	Increase the quantity to be by-passed by mining a larger portion of the west beach fillet	Not needed
·	Portable hydraulic sand bypassing	Limited technical feasibility

·	Fixed hydraulic sand bypassing	Low probability of success, cost-prohibitive

Given the difficulty and cost of effectively designing and building groins or offshore breakwaters, we recommend that fixed (permanent) structures not be considered at this time. Several years of beach survey information should be collected and examined to determine long-term impact of the marina and the effects of sand bypassing before fixed structures are considered. In addition the shore protection benefit of such structures would mitigate more damage than that associated with the marina. Thus, the cost of such structures would need to be borne jointly by the state and the private property beneficiaries.
